## Property Damage Appraisers

Damage Assessed By: Appraiser Name	Appraised For: Adjuster Name
Condition Code: Average	Type of Loss: Comprehensive
Date of Loss: 1/7/2011	
Deductible: 100.00	
File Number: ZZZ1010039	Claim Number: 0857006541
Policy No: 55KHP999999	
Insured: Jane Doe	
Address: 5555 Anywhere St, Anytown, WA 99999	
Telephone: Work Phone: (555) 444-2525	Home Phone: (555) 444-1515

Description: 2007 Honda Element LX	Vehicle Production Date: 1/07
Body Style: 4D Ut	Drive Train: 2.4L Inj 4 Cyl AWD
VIN: 5J6YH28387L999999	License: 958XXX WA
Mileage: 53,316	Search Code: PD448
OEM/ALT: A	
Color: Red	
Options: VEHICLE ANTI-THEFT, PASSENGER AIRBAG, DRIVER SIDE AIRBAG, POWER LOCK POWER WINDOW, REAR WINDOW DEFOGGER, MANUAL AIR CONDITION, CRUISE CONTROL TILT STEERING COLUMN, ANTI-LOCK BRAKE SYS., TRACTION CONTROL TIRE INFLATION/PRESSURE MONITOR, CD PLAYER, POWER ADJUSTABLE EXTERIOR MIRROR AUTOMATIC TRANSMISSION, PRIVACY GLASS, FRONT AIR DAM, FIRST ROW BUCKET SEAT SECOND ROW BUCKET SEAT, KEYLESS ENTRY, SECOND ROW FOLDING SEAT THEATER STYLE SEATING, REAR HEATING, VENTILATION & AIR CONDITIONING SECOND ROW REMOVABLE SEAT, CLOTH SEAT, VARIABLE ASSISTED STEERING, TACHOMETER SIDE AIRBAGS, P

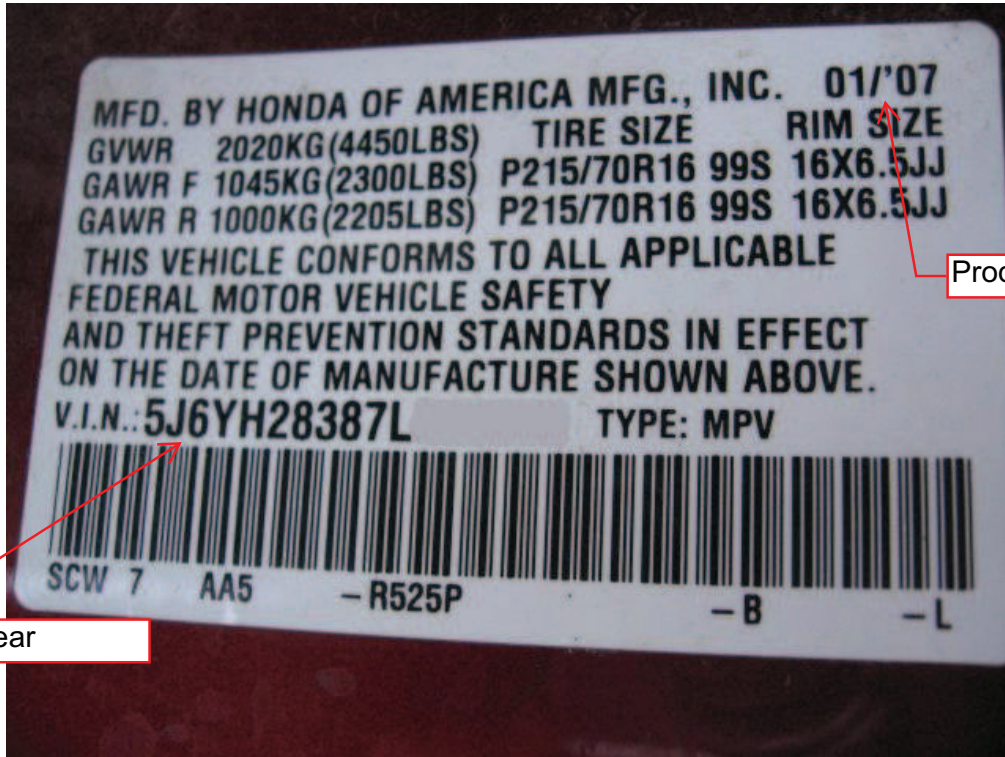
Document Name: VIN.JPG Document Type: Photo  
Remarks: Vin

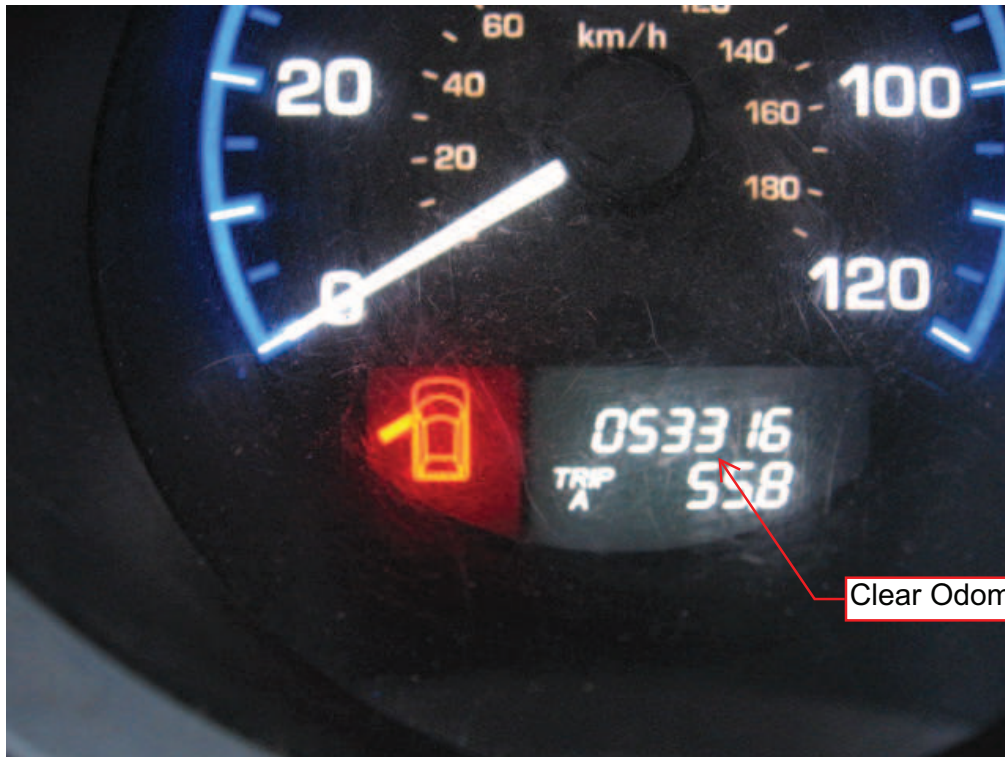
Document Name: ODOMETER.JPG Document Type: Photo  
Remarks: Odometer

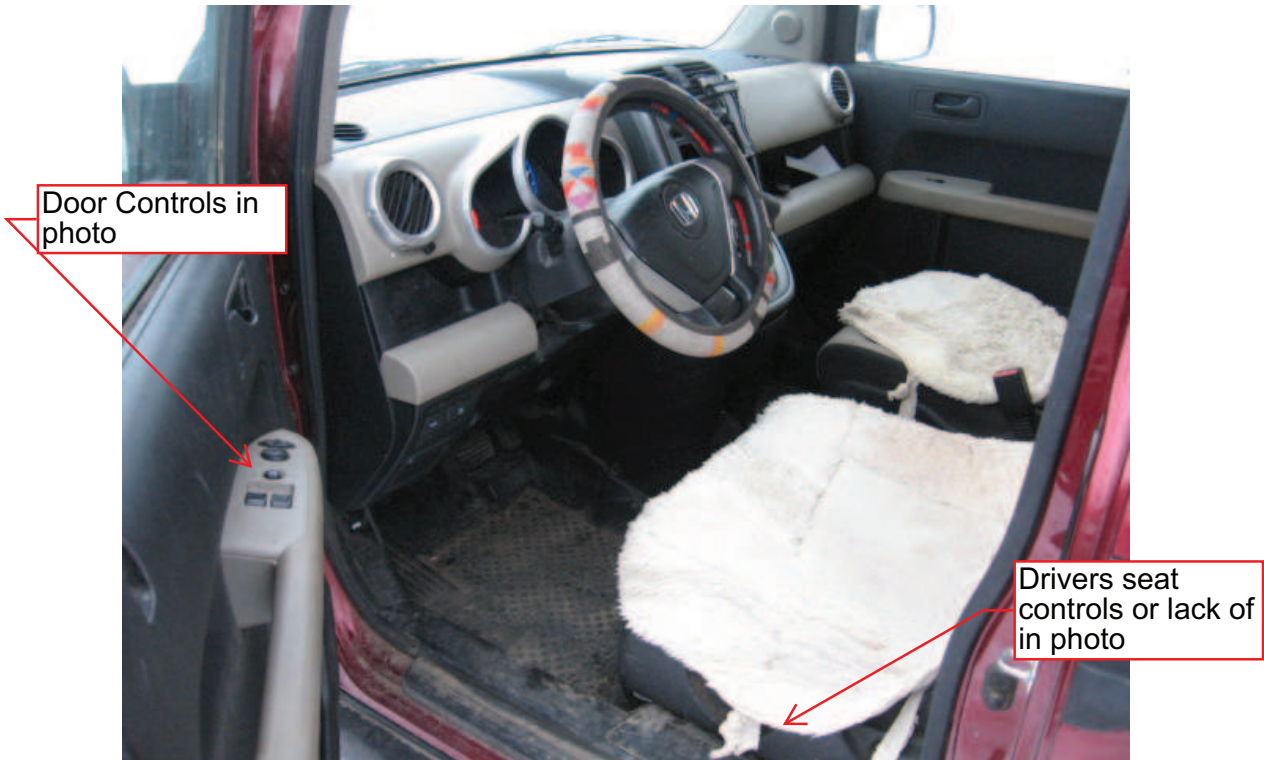
Document Name: INTERIOR.JPG Document Type: Photo  
Remarks: Interior

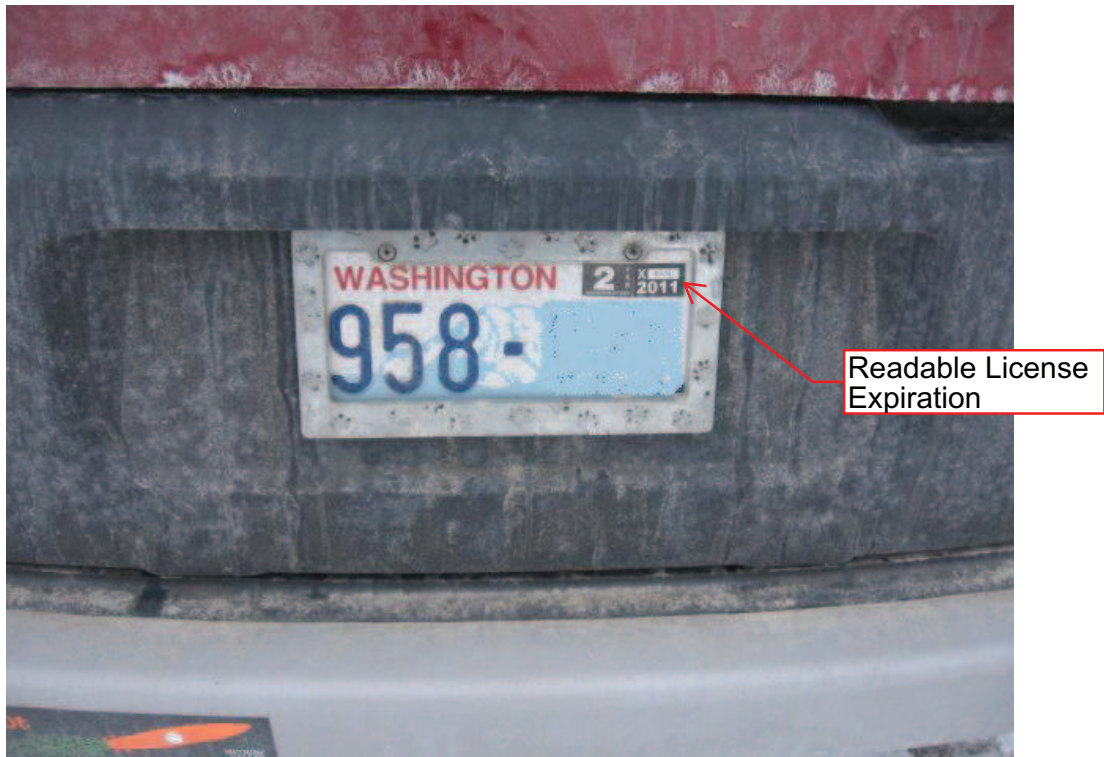
Document Name: LICENSE.JPG Document Type: Photo  
Remarks: License

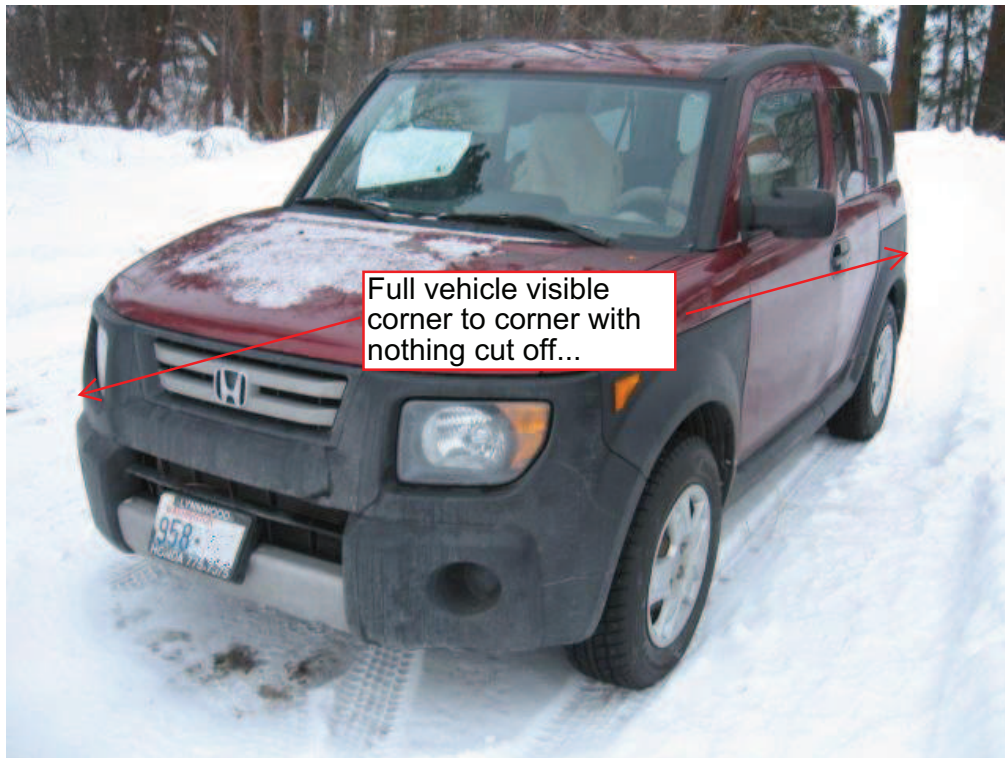
Document Name: LF CORNER.JPG Document Type: Photo  
Remarks: LF Corner

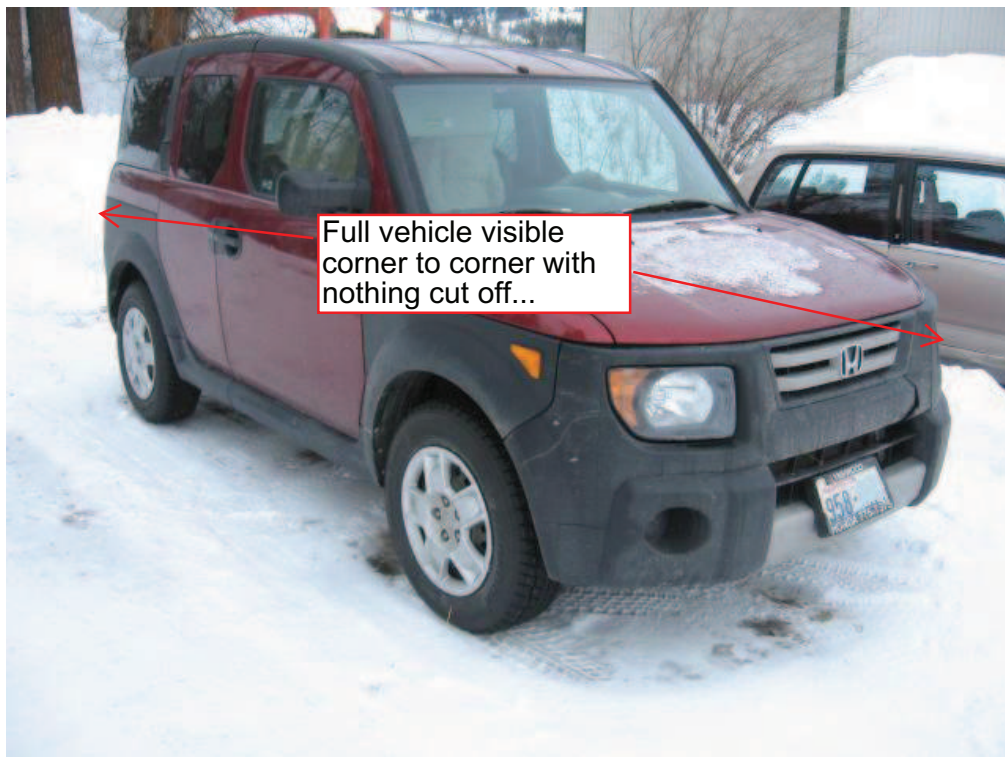
Document Name: RF CORNER.JPG Document Type: Photo  
Remarks: RF Corner

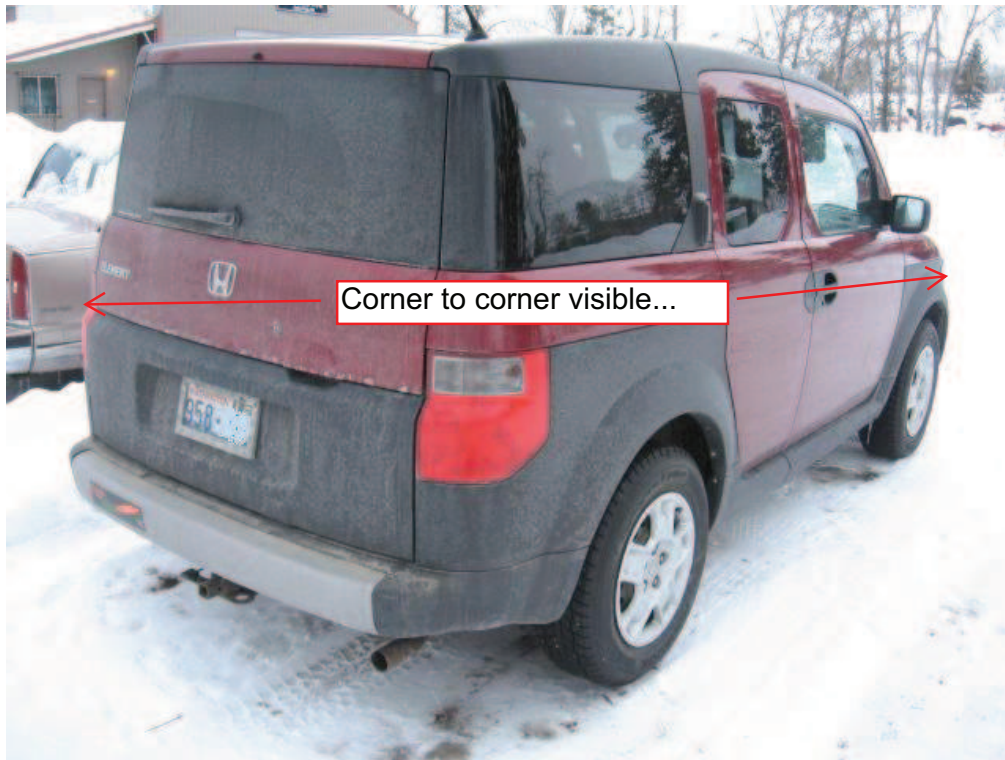
Document Name: RR CORNER.JPG Document Type: Photo  
Remarks: RR Corner

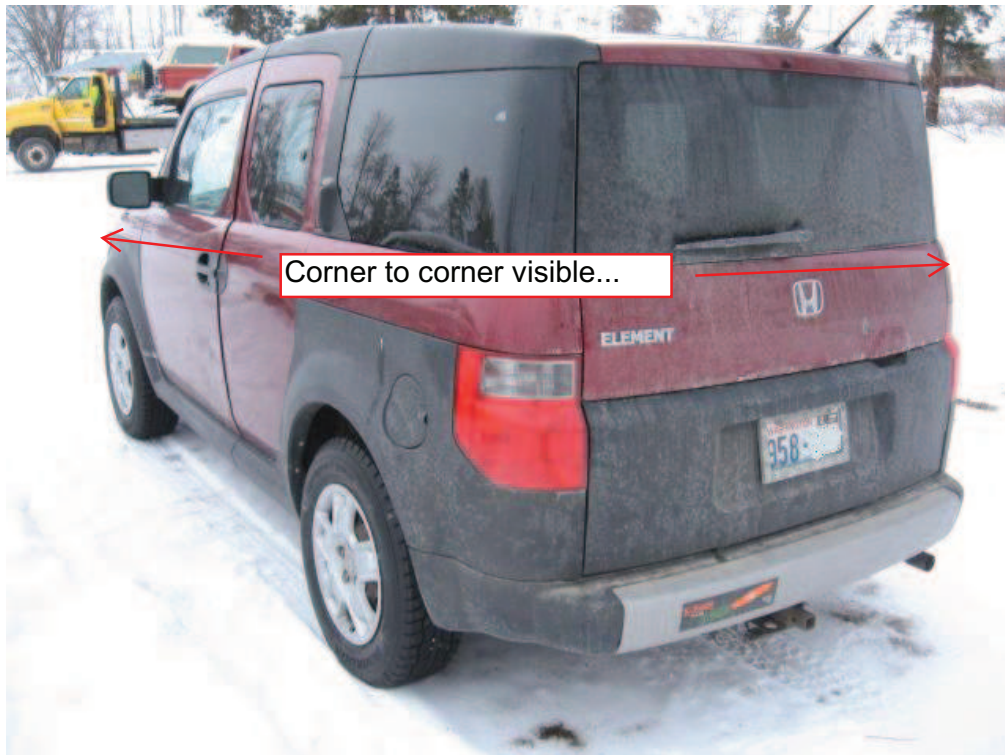
Document Name: LR CORNER.JPG Document Type: Photo  
Remarks: LR Corner

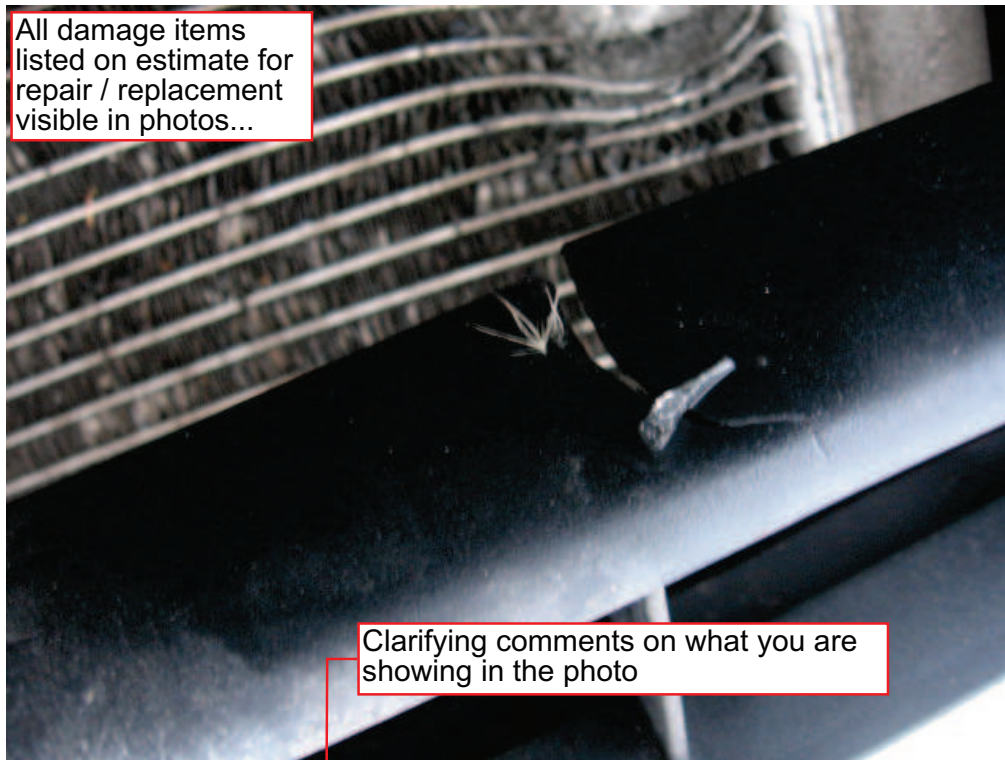
Document Name: ANIMAL EVIDENCE.JPG Document Type: Photo

Inspected vehicle at the shop of the owners choice John's Body Shop. Found damage to front bumper, license bracket, grille, radiator and cooling fan shroud. The vehicle is not driveable due to the damaged radiator. There was evidence of animal fur in the bumper cover (see photos). The vehicle was towed from the scene and the owner paid the bill. No tow bill available at the time of inspection. Vehicle also has prior damage to the left side (see photos).  
 LKQ parts could not be located at this time using Car-part.com and Mitchell QRP search. Aftermarket parts were found and used as listed on the estimate.  
 No repairs have been authorized. The owner or Insurance company needs to authorize repairs. The number of days required to repair the vehicle is 1 business day. This does not include possible parts delays.  
 The estimate is open for possible hidden damage to include the AC condenser and fan. Potential supplement \$400 - \$500.

Remarks: Front bumper / radiator damage. Note evidence of animal fur stuck in bumper.

Line Item	Entry Number	Labor Type	Operation	Line Item Description	Part Type/ Part Number	Dollar Amount	Labor Units
1	003533	BDY	REMOVE/REPLACE	Frt Bumper Cover	04711-SCV-A80ZC	314.42	1.6 #
2	004270	BDY	REMOVE/REPLACE	Frt Bumper License Bracket	71180-SCV-A00	16.48	INC
3	003908	BDY	REMOVE/REPLACE	Grille	75101-SCV-A02ZD	42.10	0.1 #
4	003922	BDY	CHECK/ADJUST	Headlamps			0.4
5	003867	BDY	REMOVE/REPLACE	Cooling Radiator	** QUAL REPL PART	228.00	1.4
6	001640	BDY	REMOVE/REPLACE	Cooling Fan Shroud	19015-PZD-A01	97.73	0.4 #
7	936003		ADD'L COST	Coolant		12.00	*

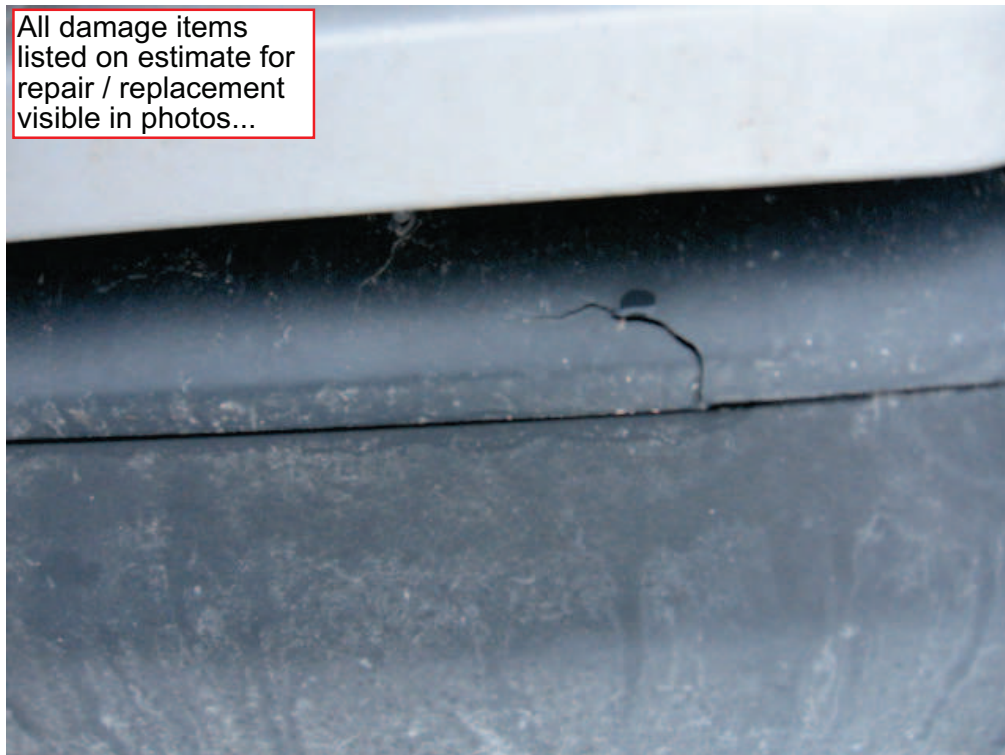
Document Name: BROKEN GRILL.JPG Document Type: Photo

Remarks: Grille insert damage

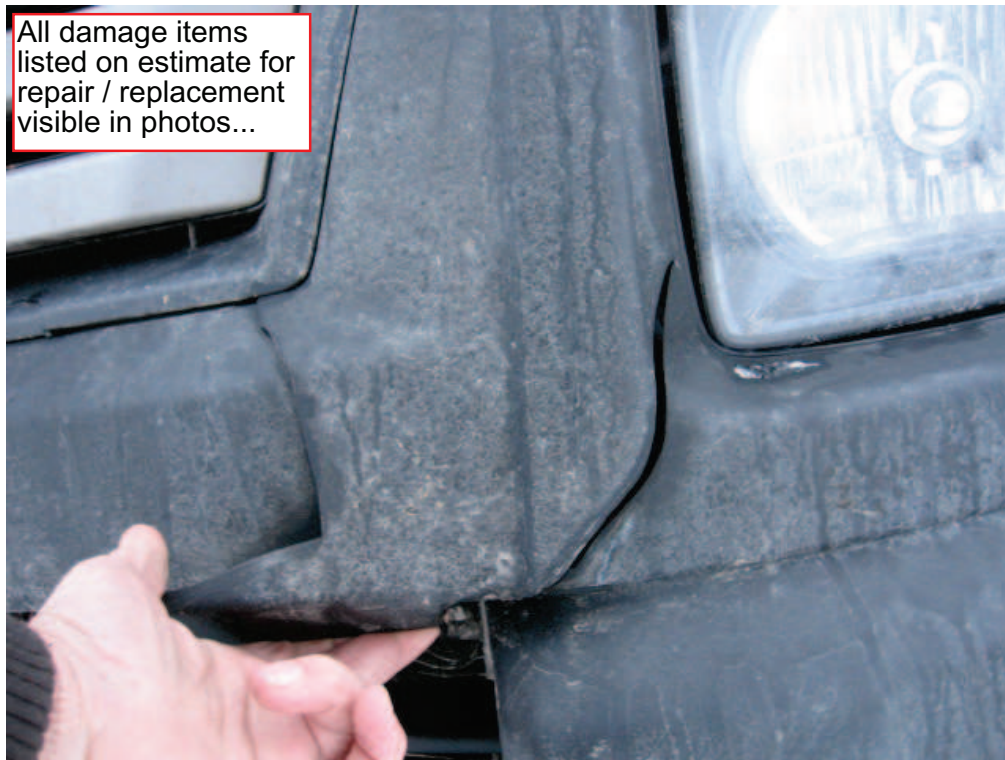
Document Name: BUMPER COVER.JPG Document Type: Photo

Remarks: Bumper cover damage

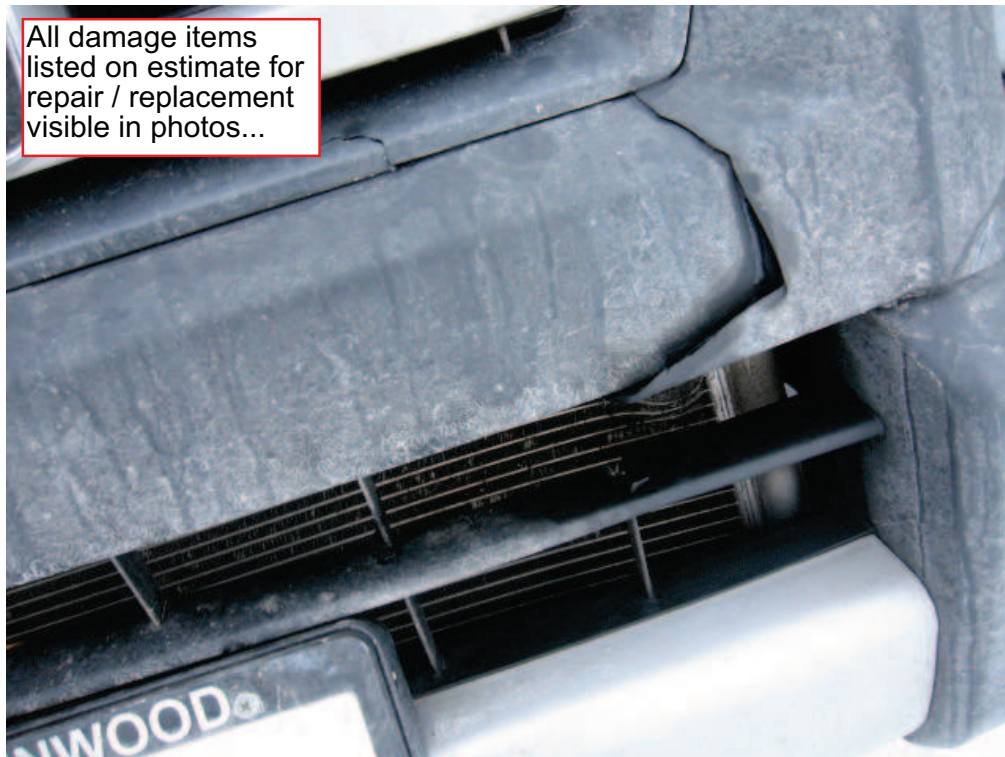
Document Name: BUMPER COVER2.JPG Document Type: Photo

Remarks: Bumper cover damage

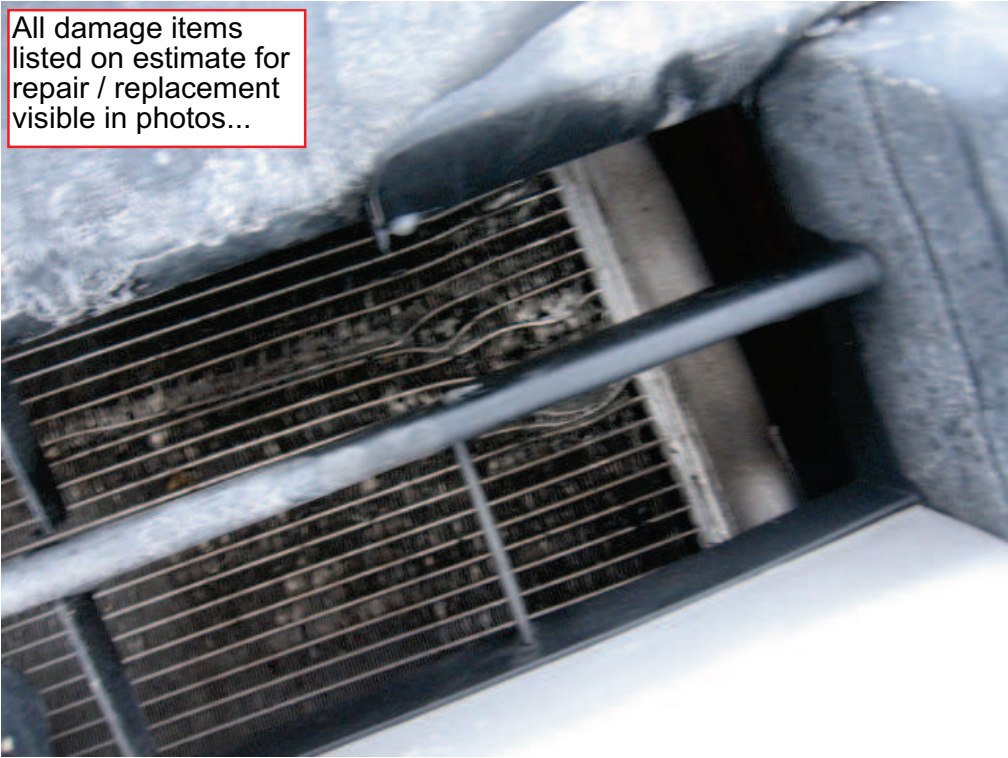
Document Name: BUMPER\_RADIATOR.JPG Document Type: Photo

Remarks: Bumper cover / radiator damage

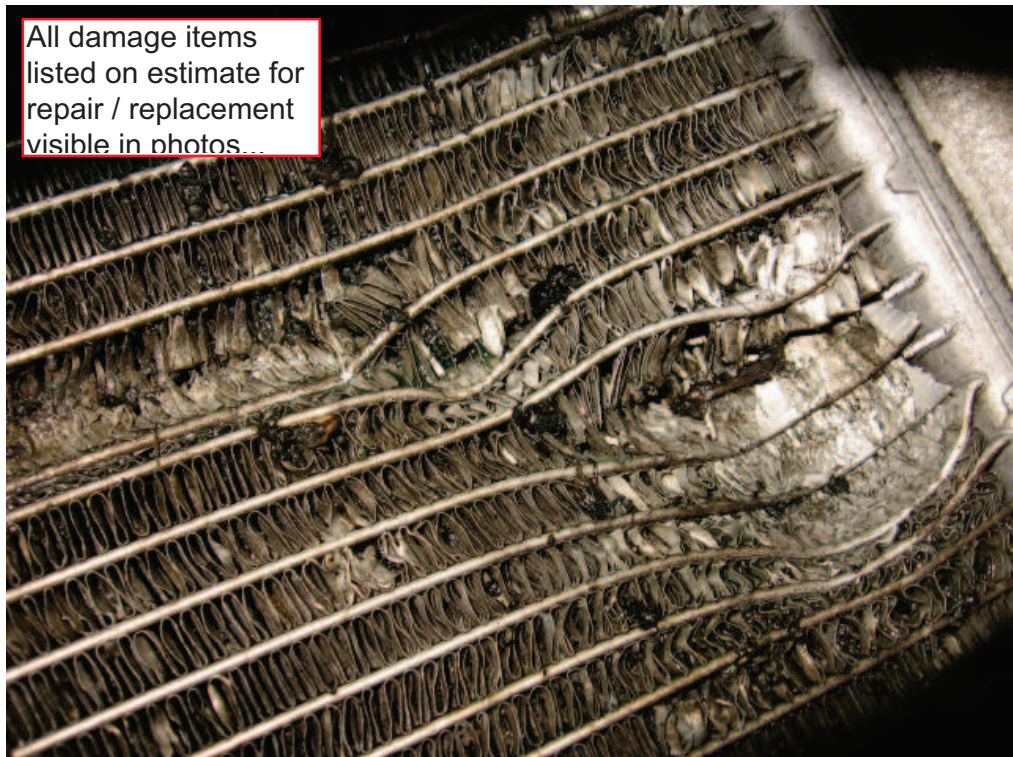
Document Name: RADIATOR.JPG Document Type: Photo

Remarks: Closeup of radiator damage, radiator does not hold fluid.

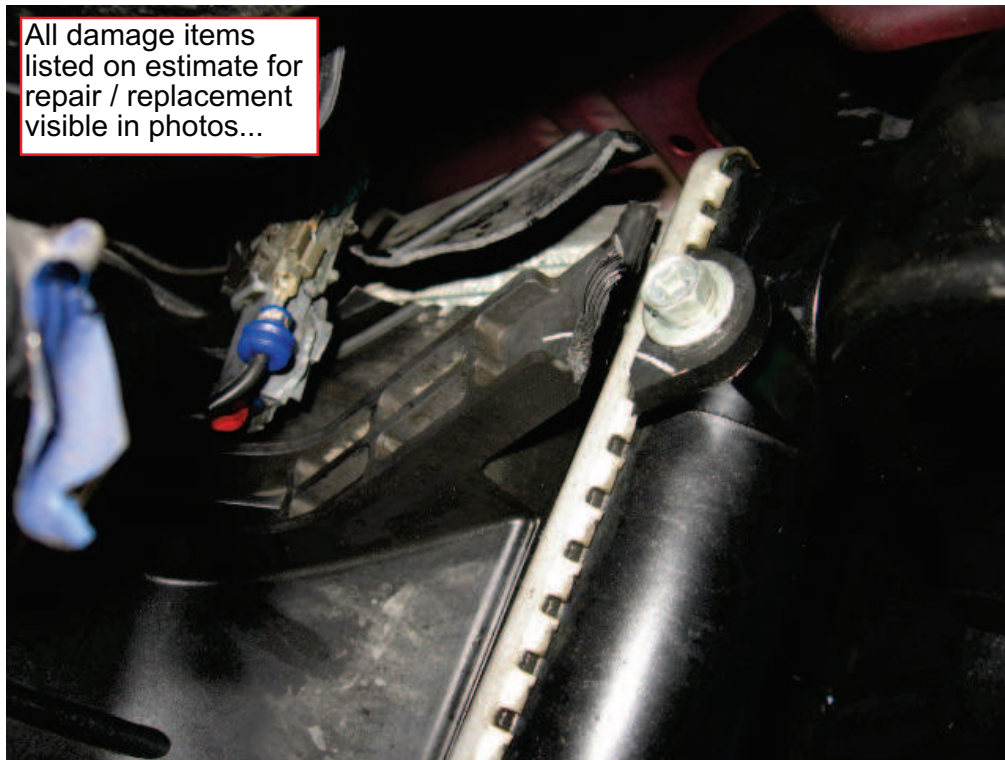
Document Name: BROKEN\_SHROUD.JPG Document Type: Photo

Remarks: Cooling fan shroud damage

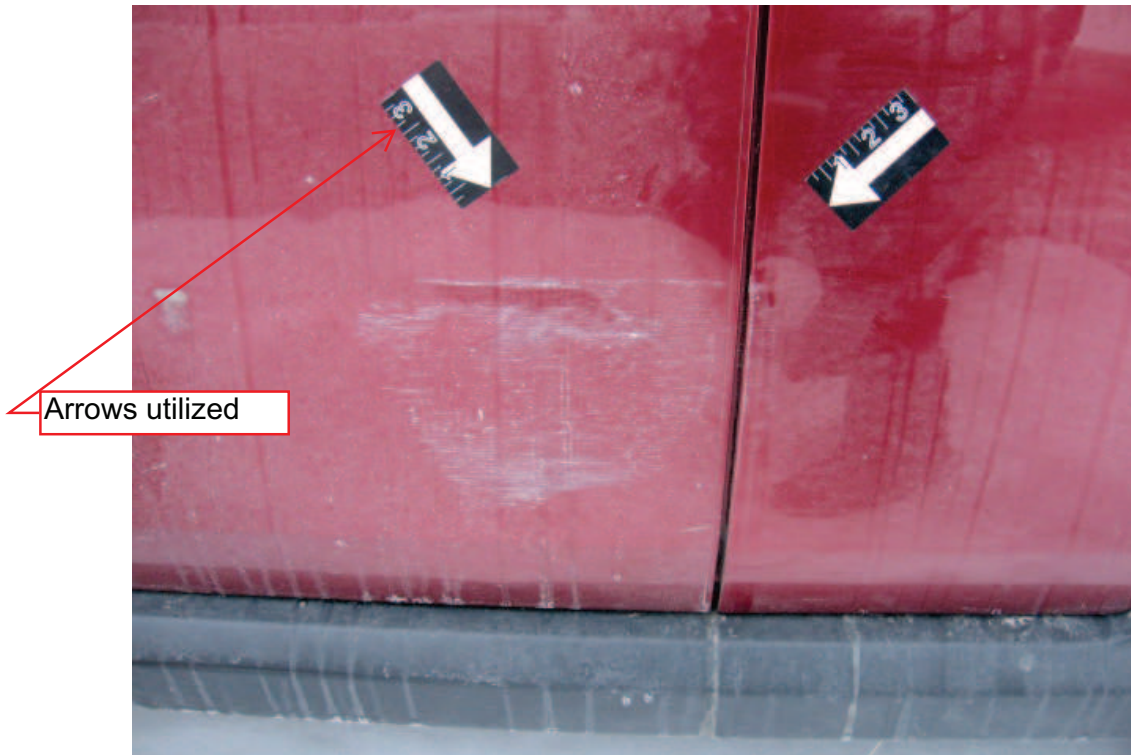
Document Name: PRIOR\_DAMAGE.JPG Document Type: Photo

Prior Damage:  
 Scraped left door and quarter.

Betterment		Old Damage	
Description	Amount	Description	Amount
<u>Not applicable</u>	_____	<u>Left Side (see photos)</u>	_____
<u>Suggested Betterment</u>	<u>0.00</u>	<u>Total Old Damage</u>	<u>0.00</u>

Remarks: Prior damage to left side.
